RE: Temporary / Construction Driveway Permit(s) # D1-2025-AR-0021
NM 136 @ MM 1.8+ in Dona Ana County.

STIPULATIONS FOR CONSTRUCTION OF DRIVEWAY ACCESS

Accept this letter of APPROVAL for purposes of retaining a temporary driveway permit only to be utilized for construction activity at NM 136 for Secondary Access. The applicant will be required to submit full set of certified construction drawings, to include all future traffic, drainage infrastructure, and permanent signing and striping. A detailed Traffic Impact Analysis shall be provided to the Department to address construction and post development impacts.

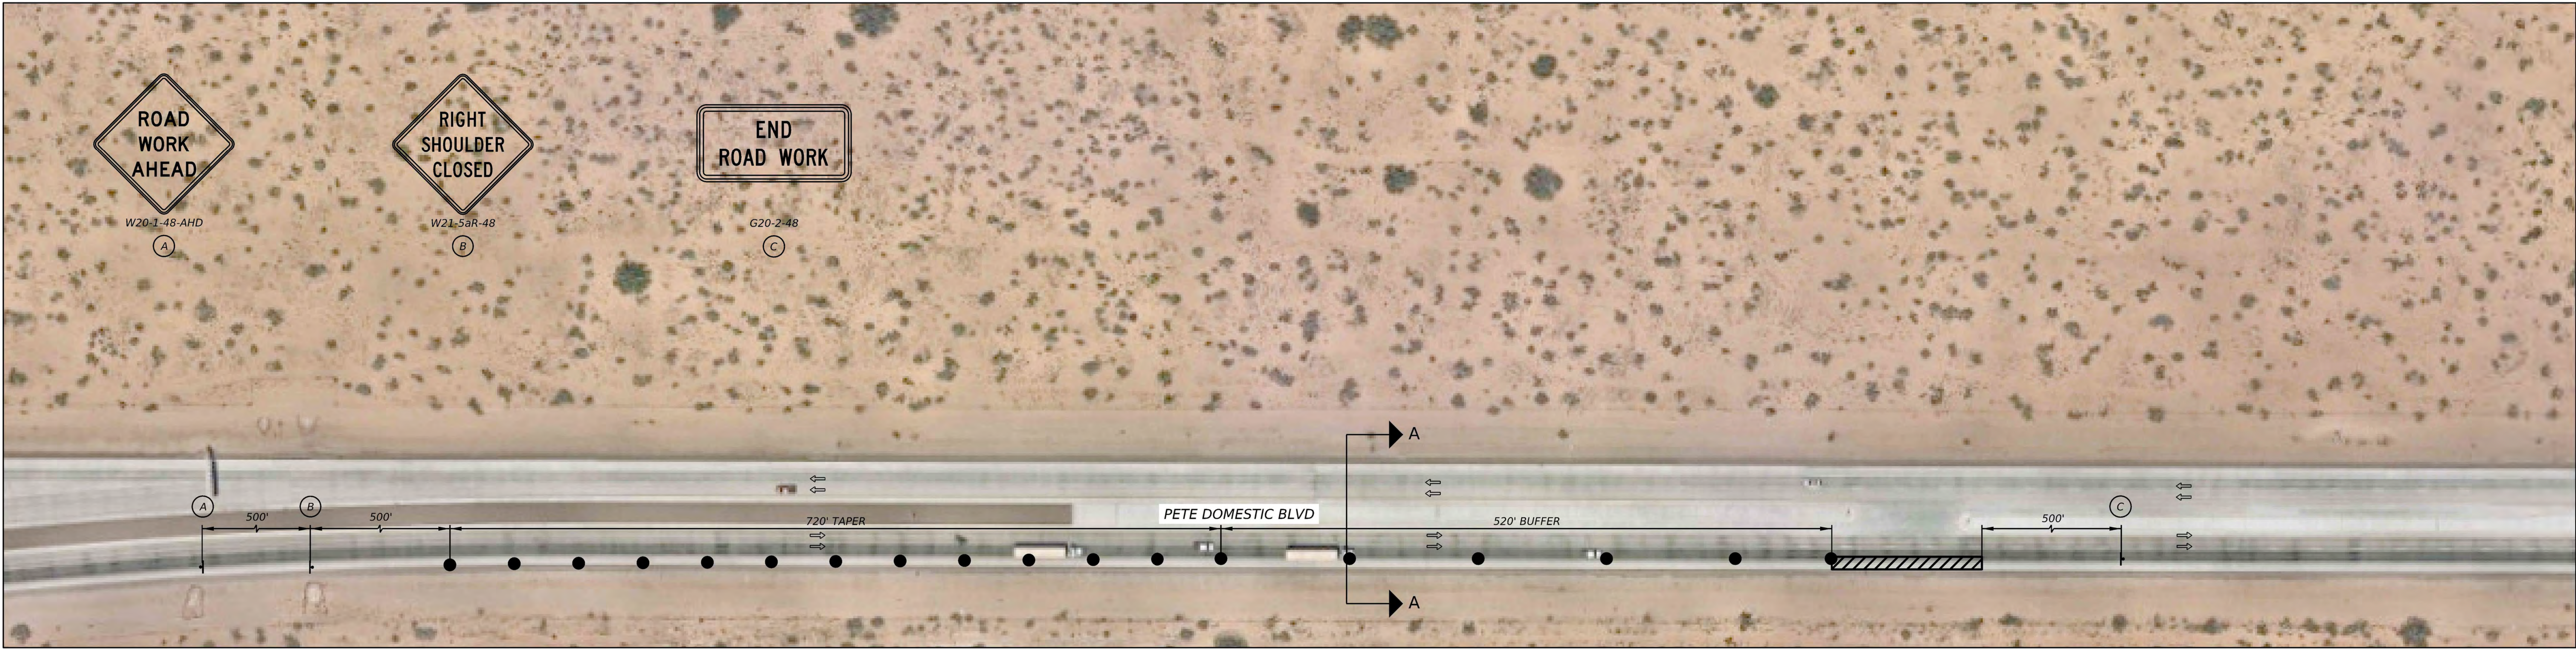
SOUTHERN TEMPORARY CONSTRUCTION ENTRANCE AT FUTURE BORDER HIGHWAY INTERSECTION

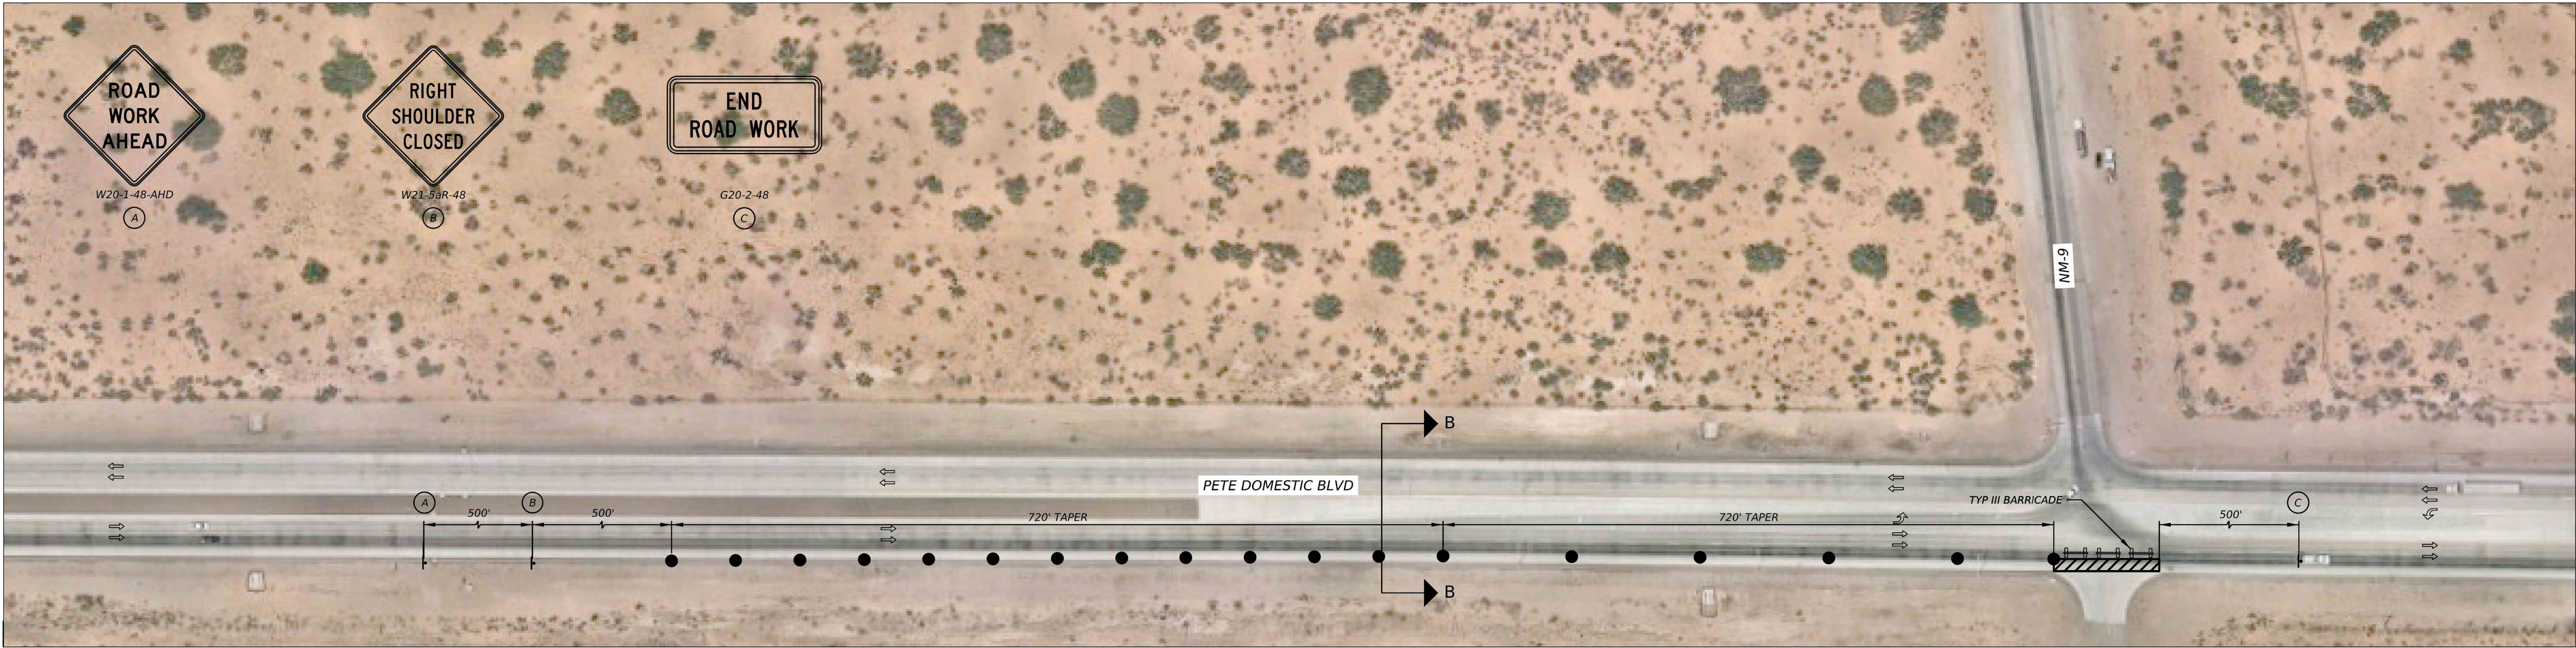
NM 9 INTERSECTION

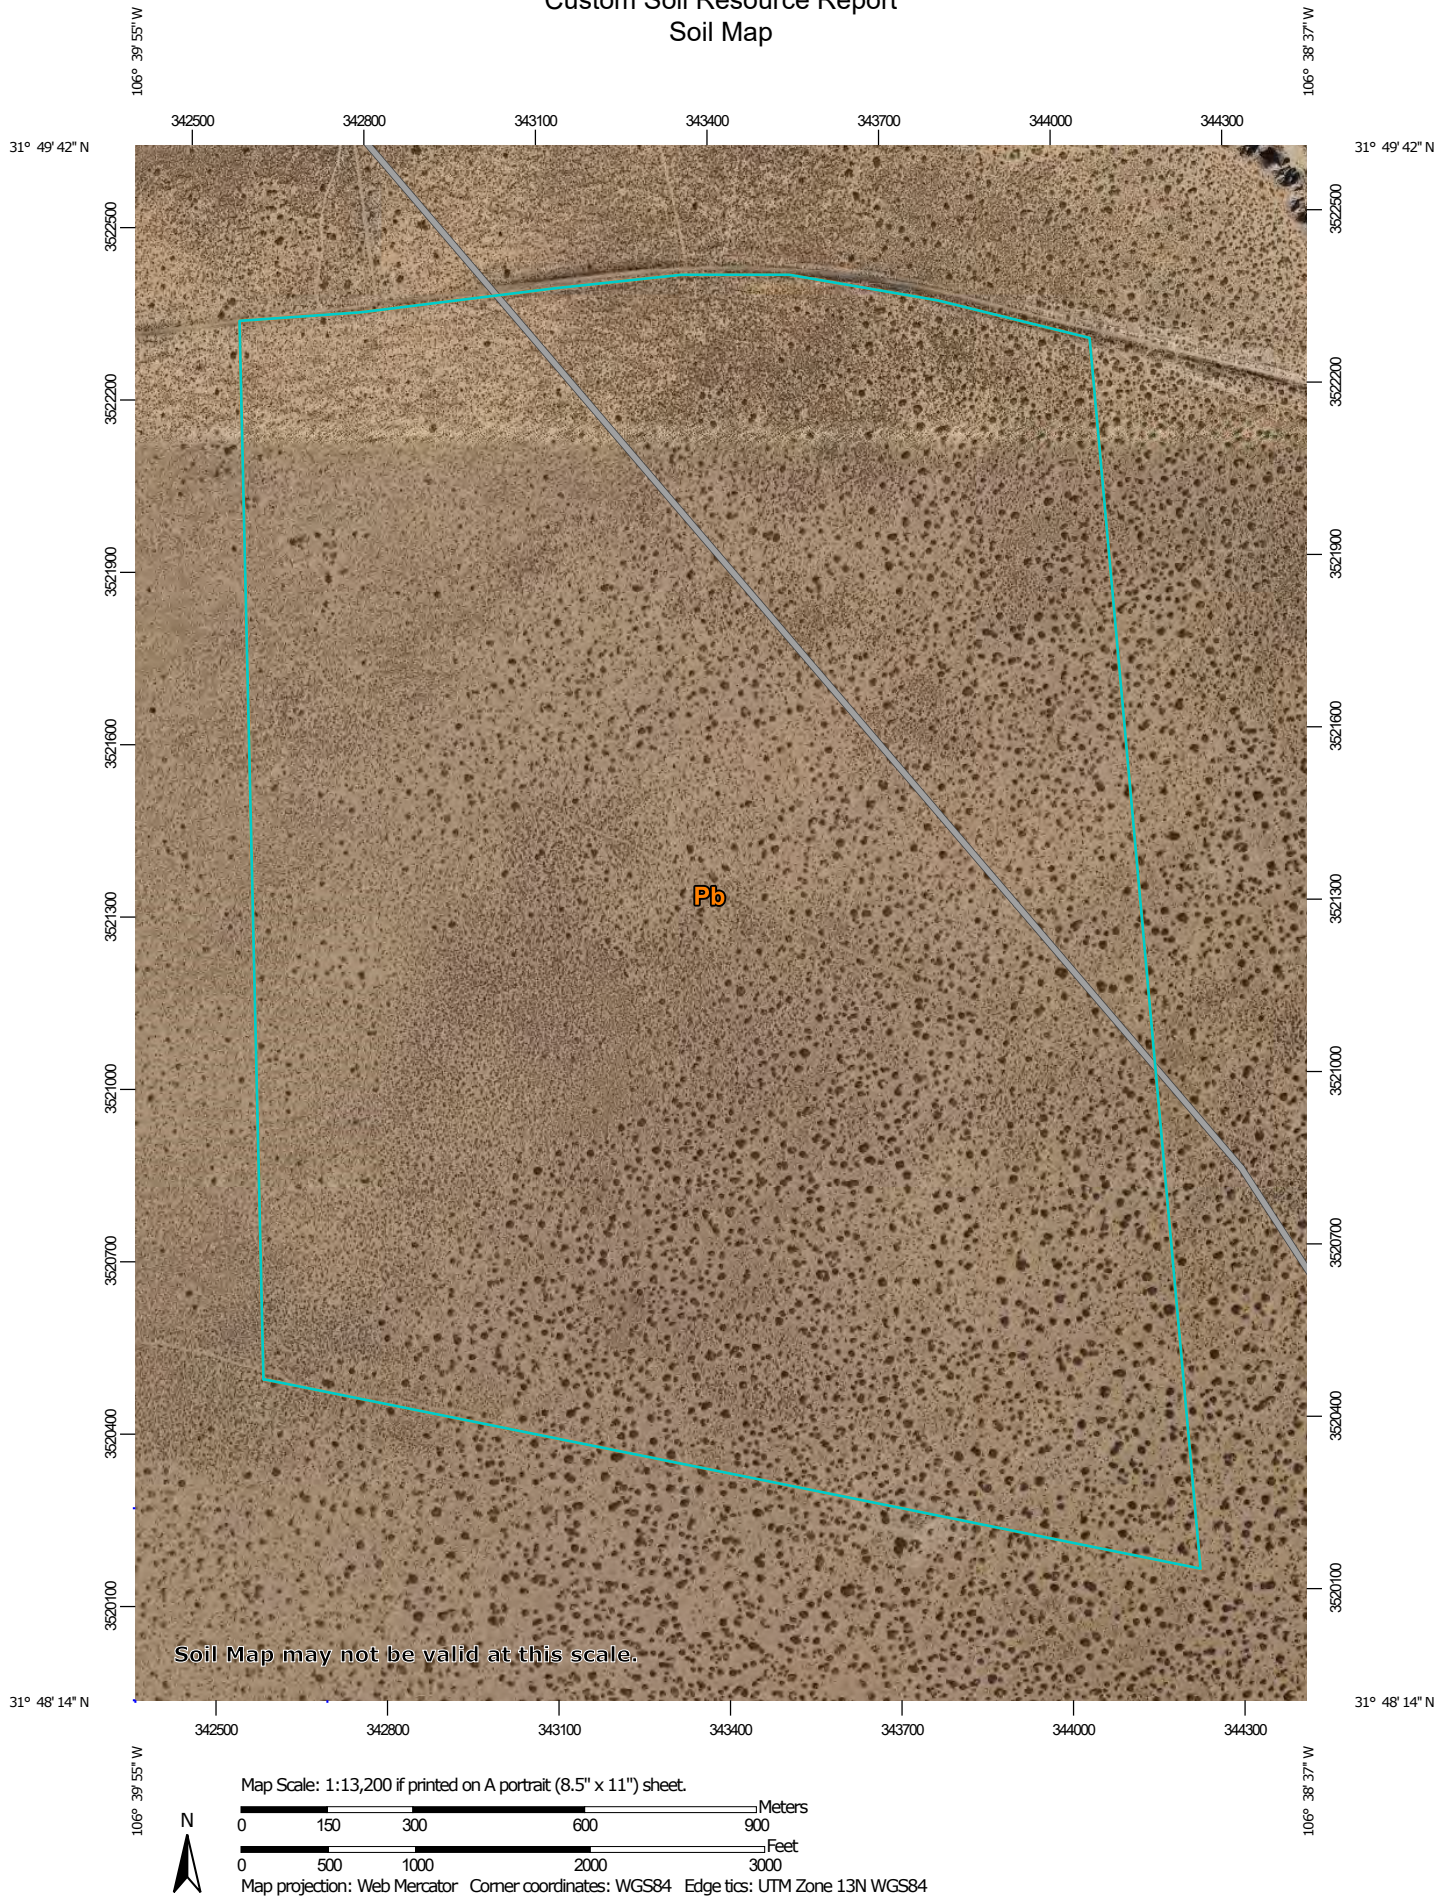
Custom Soil Resource Report Soil Map

The soil map section includes the soil map for the defined area of interest, a list of soil map units on the map and extent of each map unit, and cartographic symbols displayed on the map. Also presented are various metadata about data used to produce the map, and a description of each soil map unit.

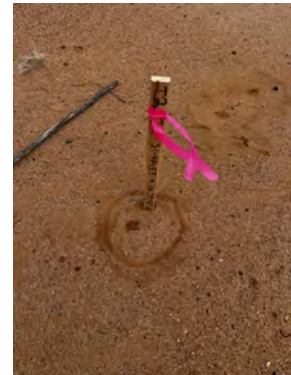
Figure 2	Likely El Paso Brown ceramic pieces, two sherds, simple reddish-brown surface. Found within close proximity to each other.	31.815442°	-106.661963°	
----------	--	------------	--------------	--

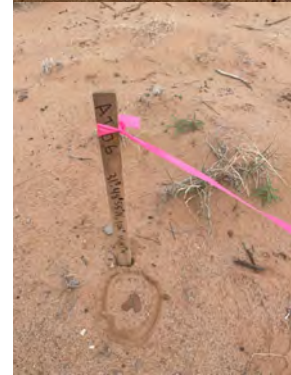
Figure 3	Likely El Paso Brown ceramic pieces, two sherds, simple brown/reddish-brown surface. Found within close proximity to each other.	31.815278°	-106.661667°	
----------	--	------------	--------------	--

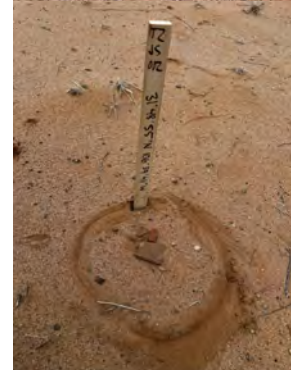
Figure 4	Likely El Paso Brown ceramic pieces, three sherds, simple brown and reddish-brown surfaces. Found within close proximity to each other.	31.815278°	-106.661389°	
----------	---	------------	--------------	--

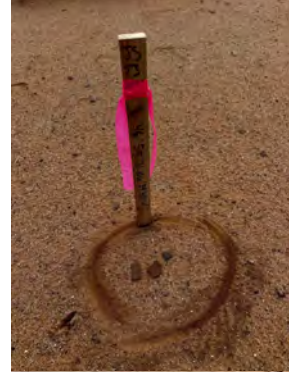
Figure 5 Likely El Paso Brown ceramic pieces, three sherds, simple reddish-brown and dark gray surfaces. Found within close proximity to each other. 31.815278° -106.661111°

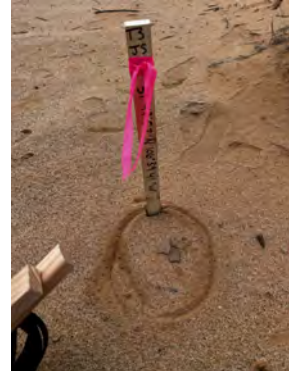
Figure 6 Likely El Paso Brown ceramic pieces, three sherds, simple brownish-gray surfaces. Found within close proximity to each other. 31.814444° -106.661389°

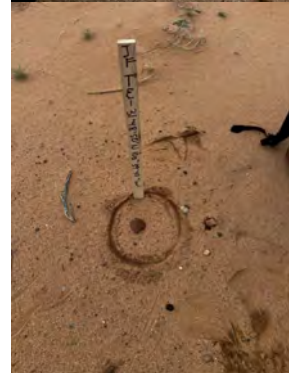
Figure 7 Likely El Paso Brown ceramic piece, single sherd, simple brown surface. 31.813889° -106.661111°

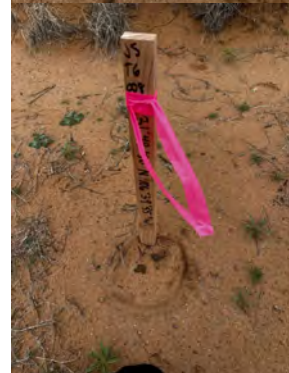
Figure 8 Likely El Paso Brown ceramic pieces, two sherds, simple dark brownish-gray surfaces. Found within close proximity to each other. 31.813889° -106.659722°

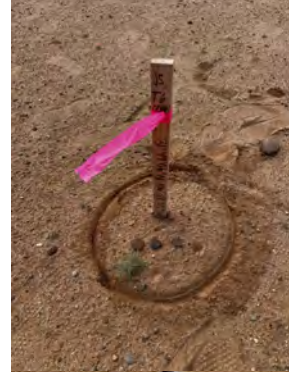
Figure 13 Likely El Paso Brown ceramic pieces, three sherds, simple dark brown surfaces with black/gray spot(s). Found within close proximity to each other. 31.818056° -106.659444°

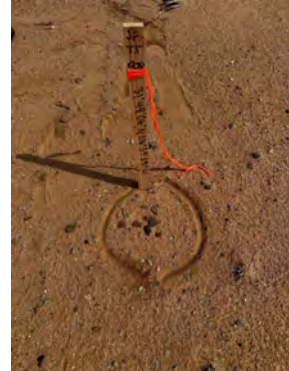
Figure 14 Likely El Paso Brown ceramic pieces, multiple sherds, simple dark brown surfaces and black/gray spots. Found within close proximity to each other. 31.818333° -106.659722°

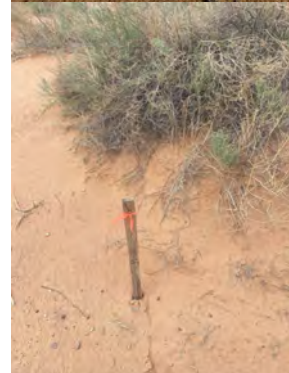
Figure 15 Likely El Paso Brown ceramic piece, single sherd, simple brown surface. 31.818257° -106.658090°

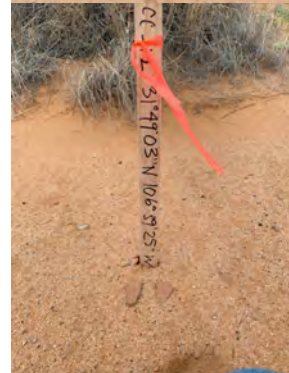
Figure 16 Likely El Paso Brown ceramic pieces, two sherds, simple light brown surfaces. Found within close proximity to each other. 31.817633° -106.657033°

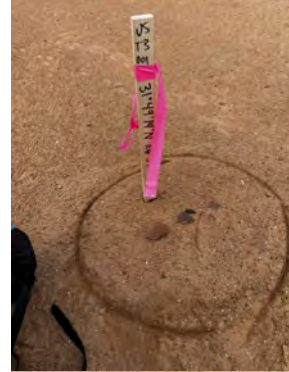
Figure 17 Likely El Paso Brown ceramic pieces, three pieces, simple brown and reddish-brown surfaces. Found within close proximity to each other. 31.820556° -106.658333°

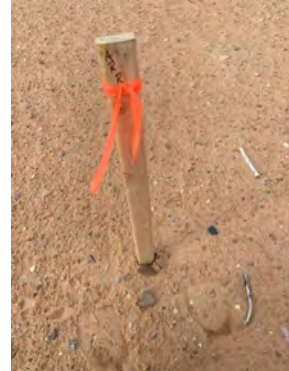
Figure 18 Likely El Paso Brown ceramic pieces, two sherds, simple brown and gray surfaces. Found within close proximity to each other. 31.820557° -106.657908°

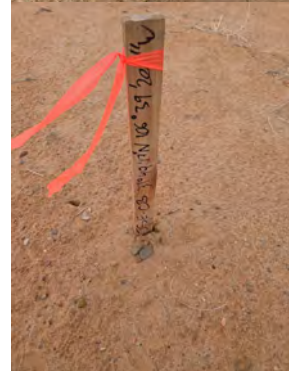
Figure 19 Likely El Paso Brown ceramic pieces, three sherds, simple light brownish-gray surfaces. Found within close proximity to each other. 31.821502° -106.655599°

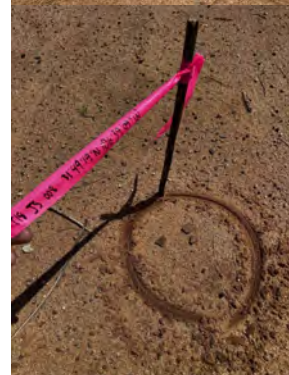
Figure 24 Likely El Paso Brown ceramic pieces, three sherds, simple dark brown surfaces. 31.821944° -106.652500°

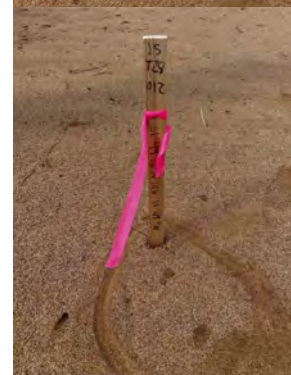
Figure 28 Likely El Paso Brown pieces, three sherds, simple brown and reddish-brown surfaces. Found within close proximity to each other.

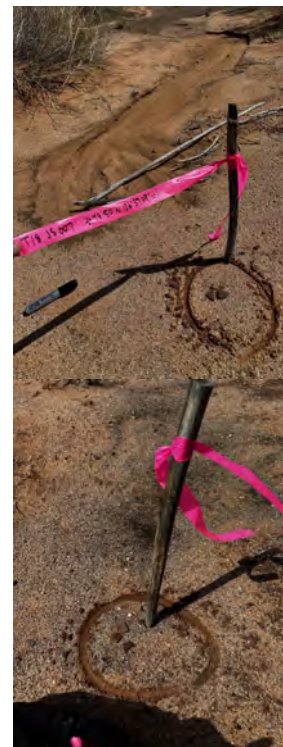
Figure 32 Likely El Paso Brown ceramic pieces, three sherds, simple reddish-brown and dark brown surfaces. Found within close proximity with each other.

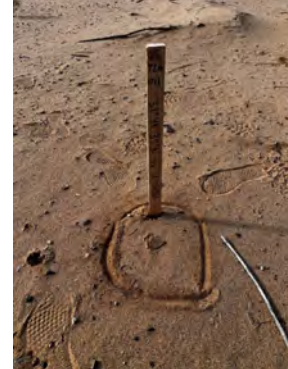
Figure 34 Likely El Paso Brown ceramic piece, single sherd, simple brown surface. 31.810833° -106.648333°

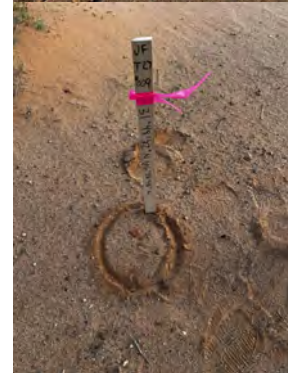
Figure 35 Likely El Paso Brown ceramics, two sherds, simple reddish-brown surfaces. Found within close proximity to each other. 31.808889° -106.646944°

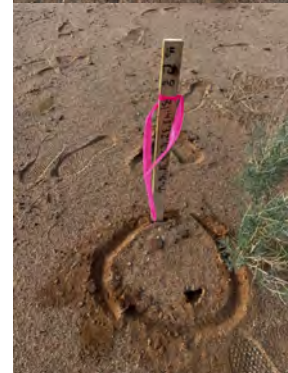
Figure 36 Likely El Paso Brown ceramics, two sherds, simple brown and reddish-brown surfaces. Found within close proximity to each other. 31.808889° -106.646389°
